SLAB STAGE INSPECTION

Client Details	
Client	YU-HSIEN SU (nickname:Kat) 0432778495 yuhsiensu@hotmail.com
Address	3 king fern way, Forest Glen QLD4556
Builder	Edge design Homes
Type of Building	Residential
Building Inspector	James Smith
A1 Reference	SS-A1-3156

Date of the Inspection: 18/08/2021 **Time of Inspection:** 4 pm

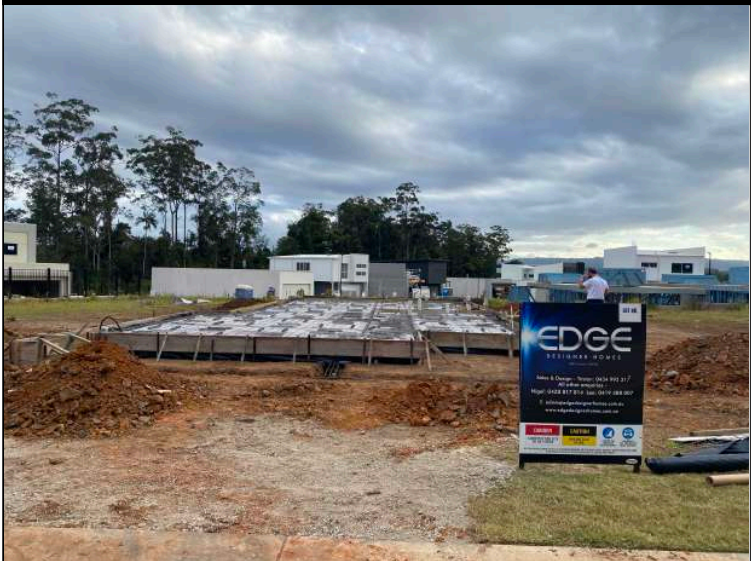
<p>Showing front elevation of the lot / land</p>

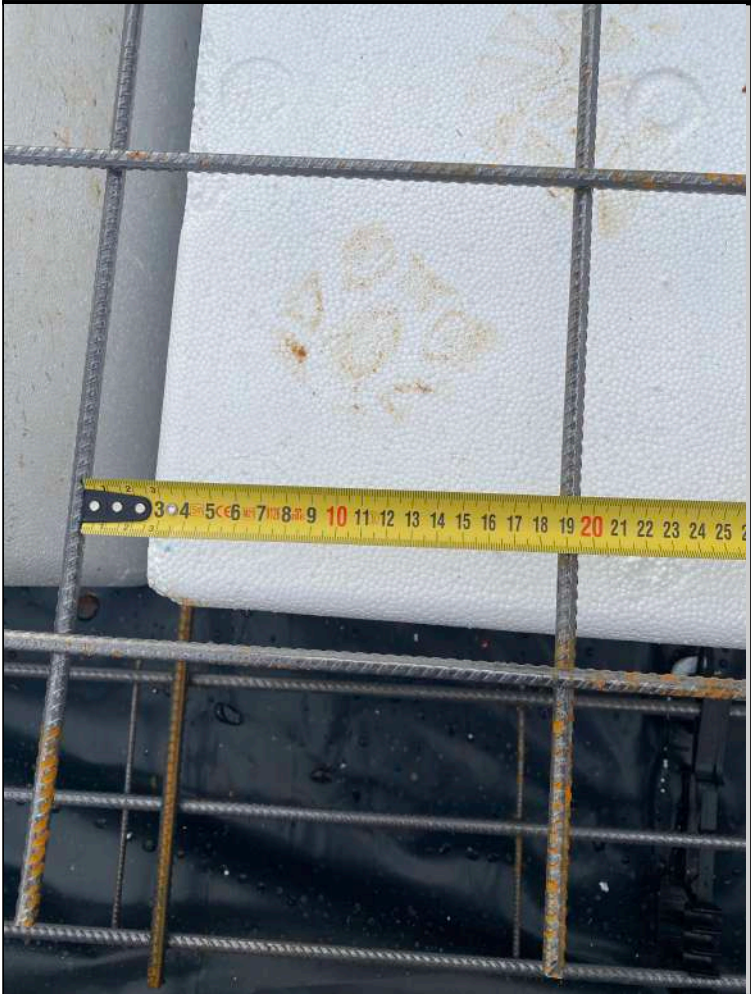
<p>Showing rio bar / mesh and waffle pads installation</p>

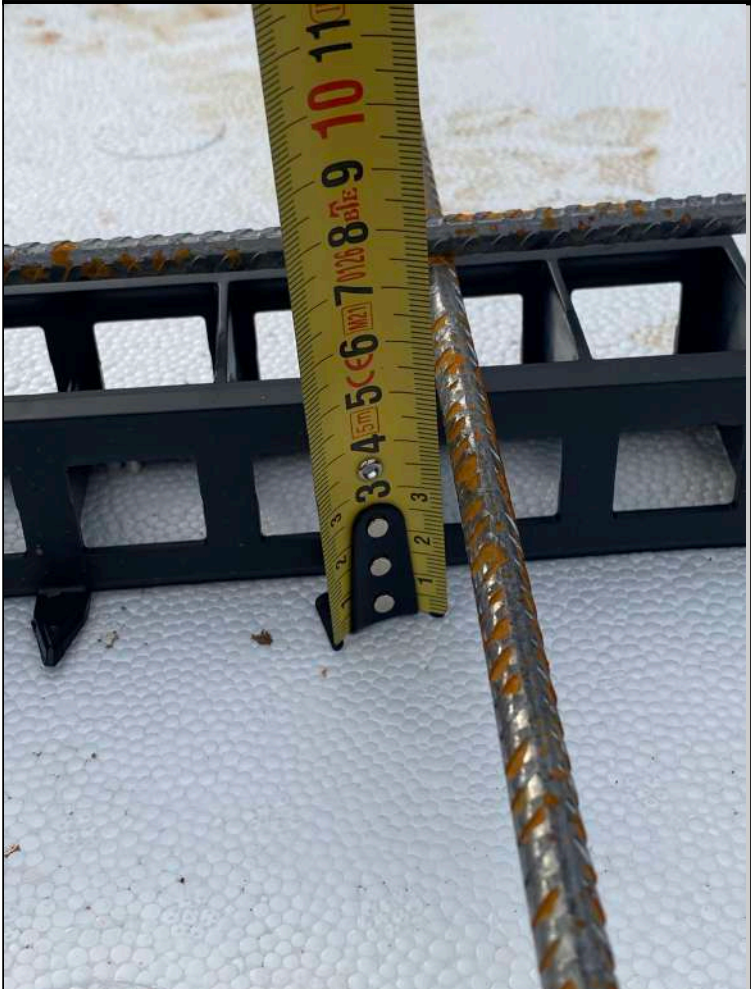
<p data-bbox="981 577 1374 745">Spacers been fitted in proper set up to provide sufficient concrete coverage</p>

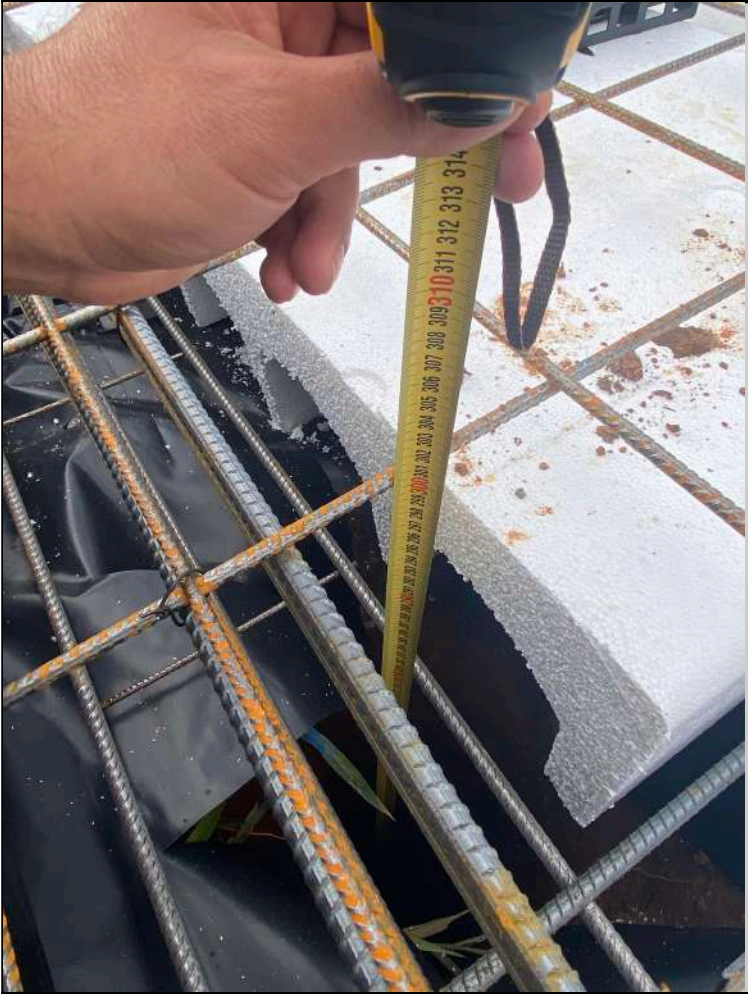
<p>Deep footing in rear elevation, approximately 2500mm depth</p>

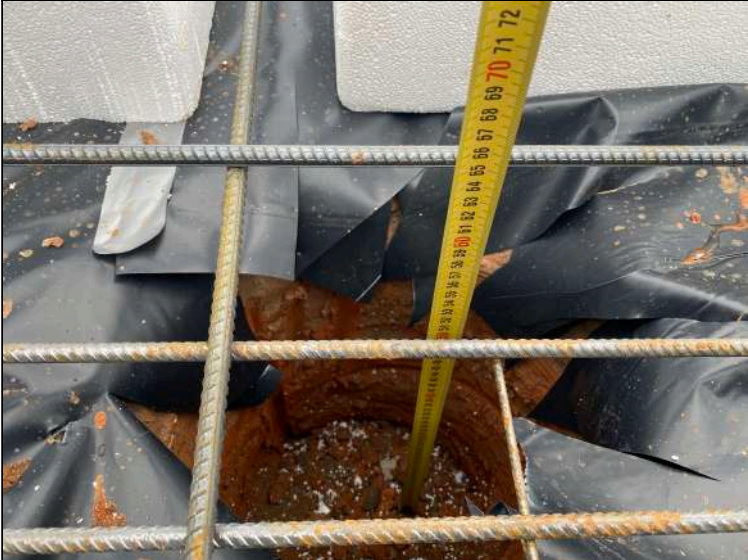
<p>Shallow footings on the sides, approximately 500mm depth</p>

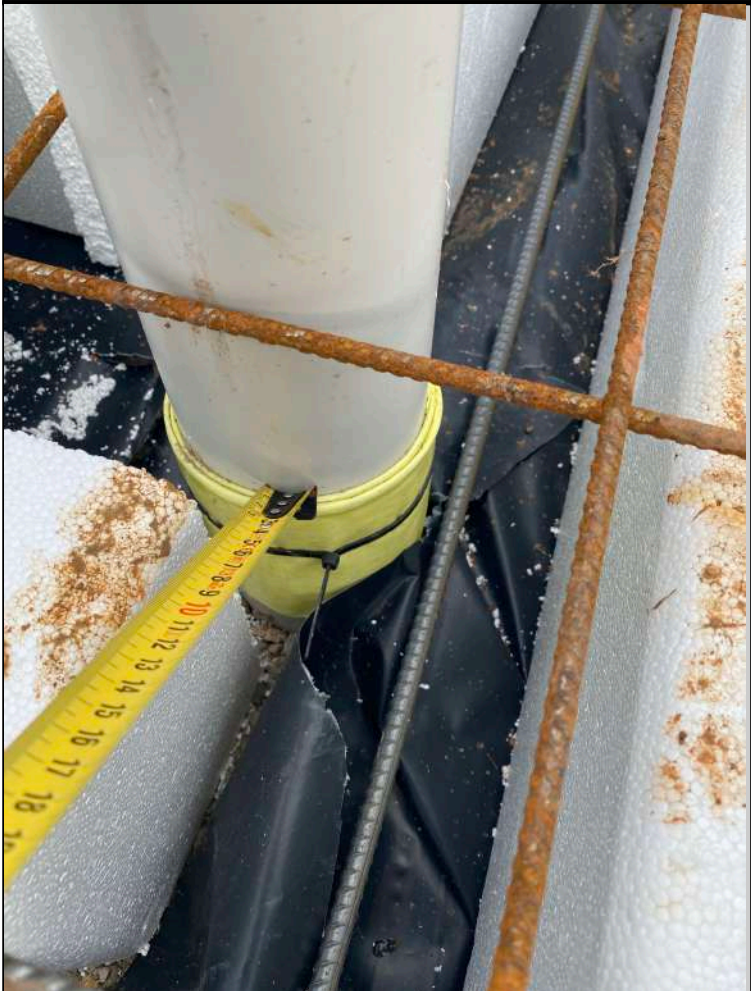
<p>Termite management system, collar around pipe penetration points</p>

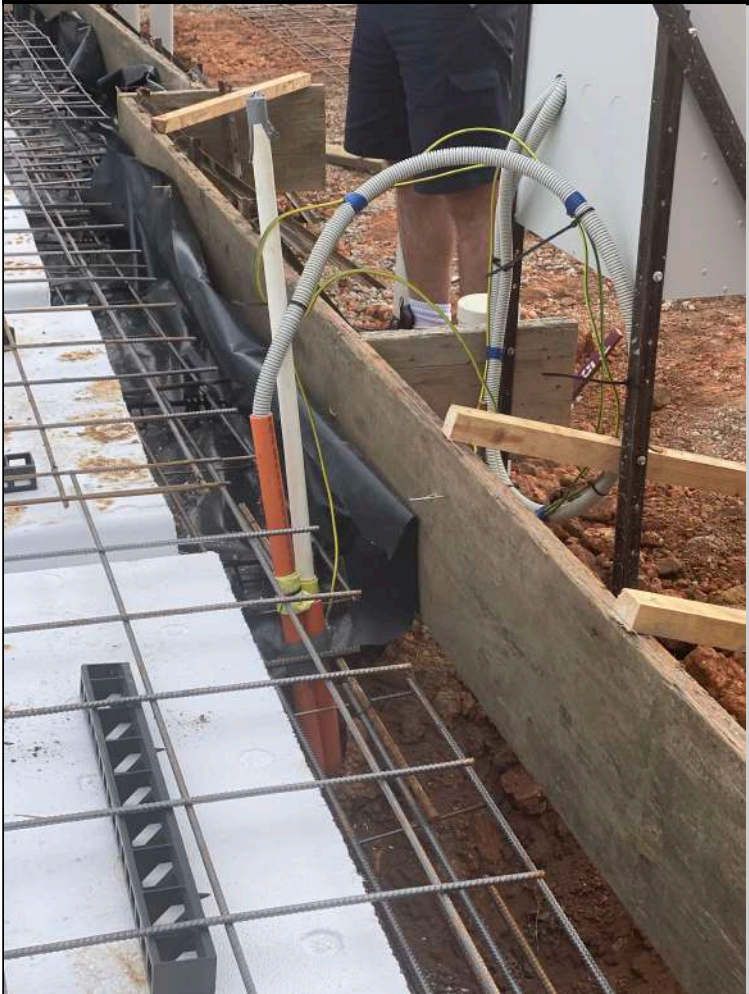
<p data-bbox="981 510 1380 593">Earth wiring to the RHS elevation ,</p> <p data-bbox="1005 638 1356 761">Also vapour barrier installed underneath foundation</p>
