10 Dunstan Crescent, 4500 Strathpine

Pre-Purchase Standard Property & Timber Pest Report

Report number:	H-A1-2189
Inspection Date:	24th Mar, 2021
Property Address	10 Dunstan Crescent, 4500 Strathpine

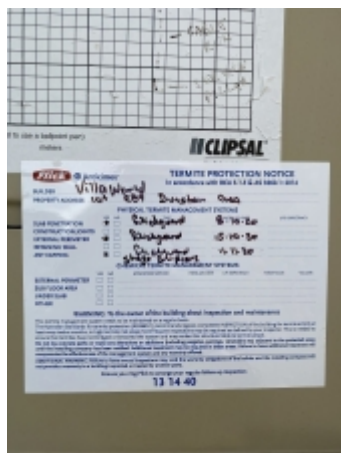
E1 Active (live) termites	No evidence was found
E2 Subterranean termite management proposal	A Proposal is recommended
Additional Comments	
E3 Termite workings and/or damage	No evidence was found
E4 Previous termite management program	The following evidence was found:
Evidence of previous program:	Treatment sticker in meter box

Showing evidence of termite management sticker affixed into the Meterbox

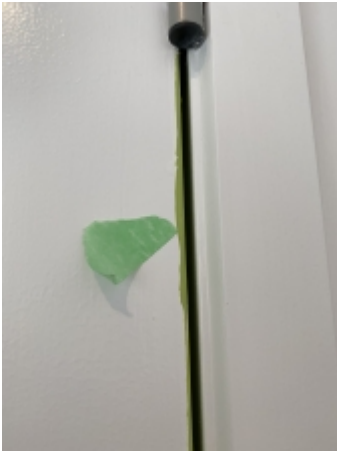
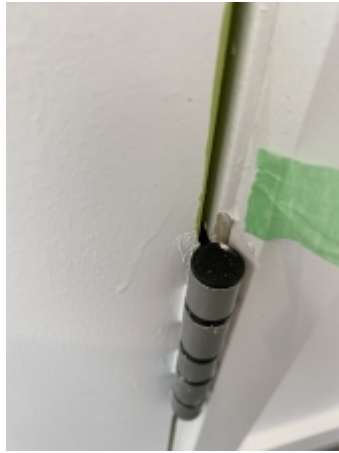
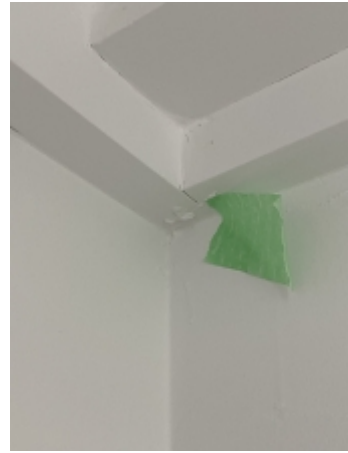
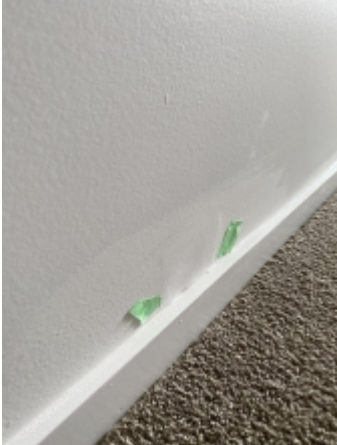
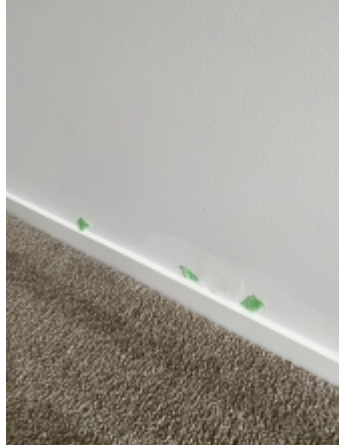
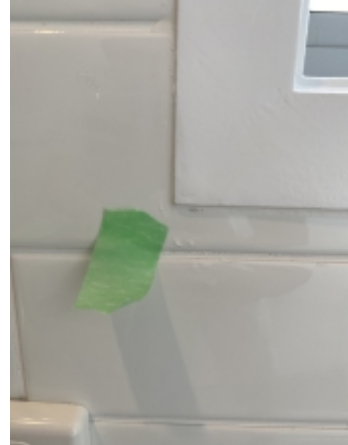
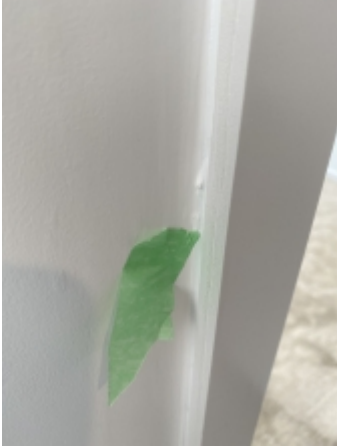
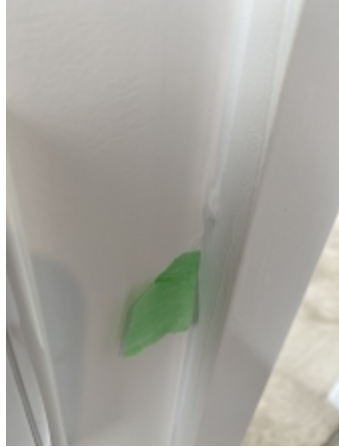
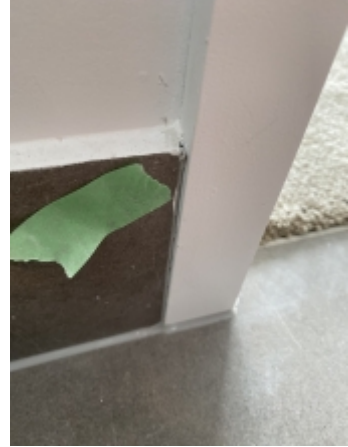
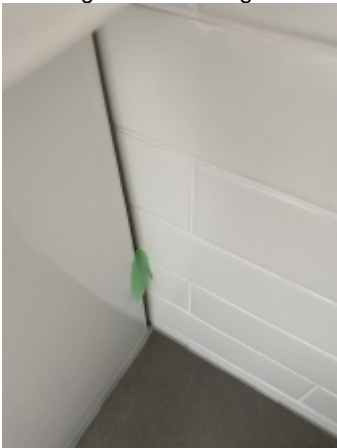
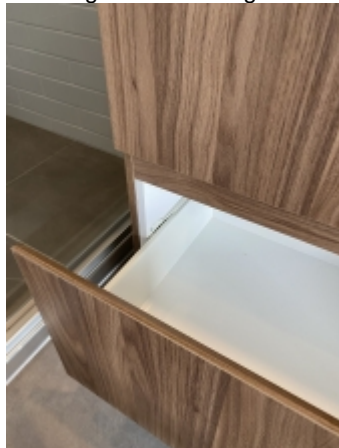
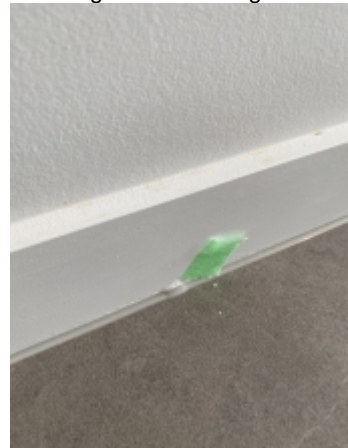
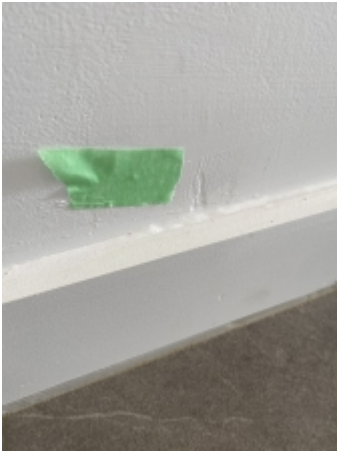
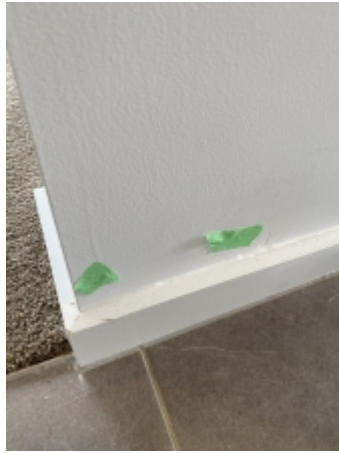
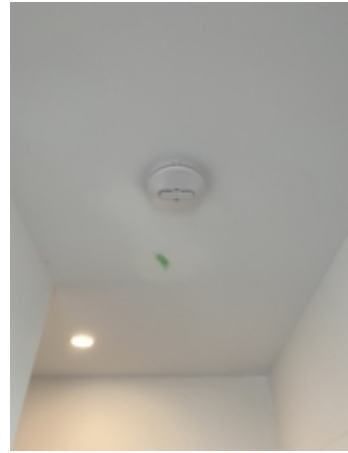
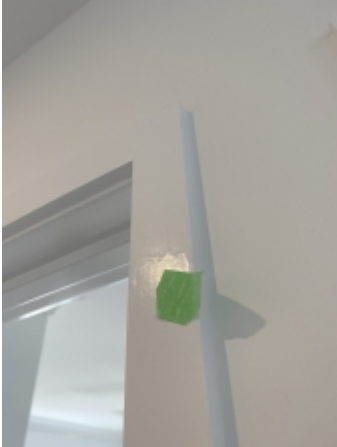
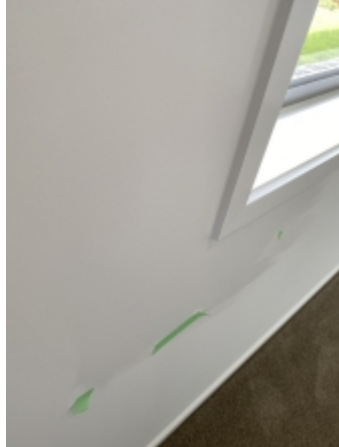
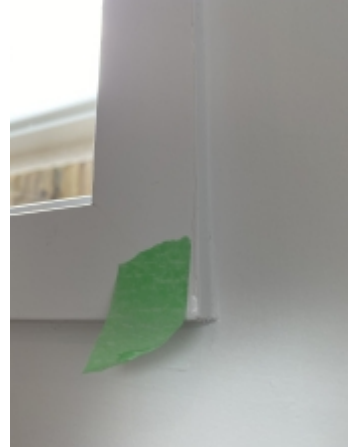
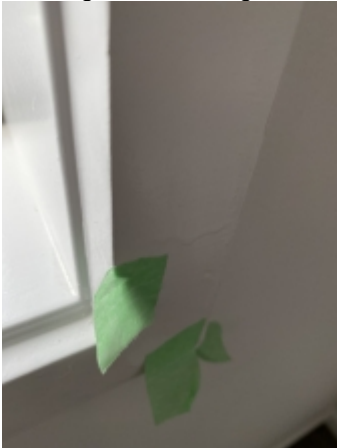
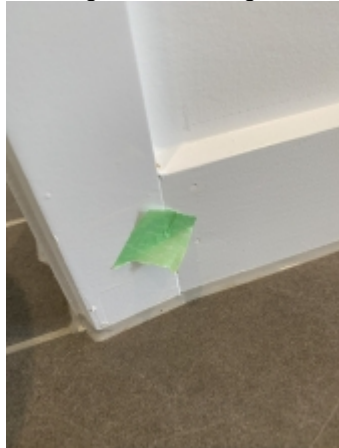
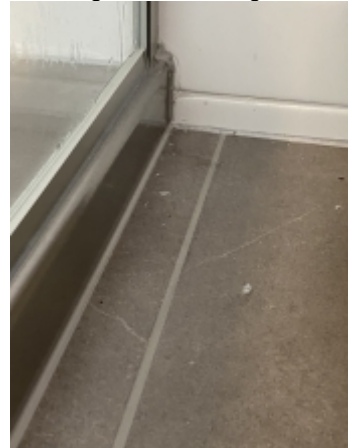
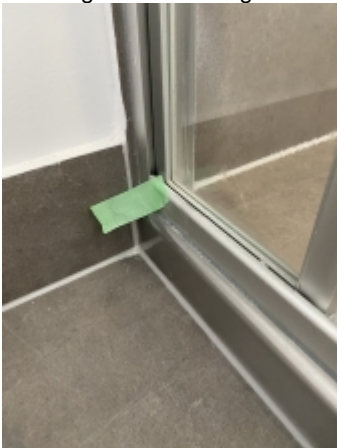
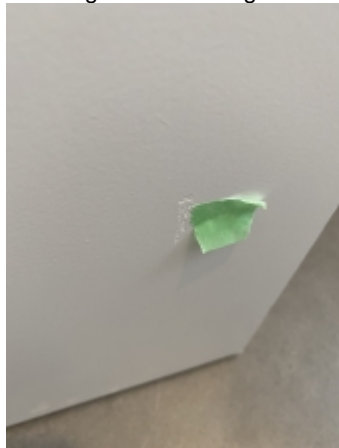
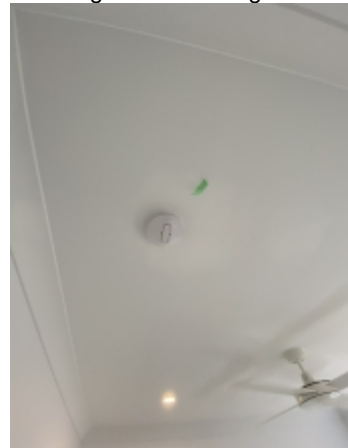
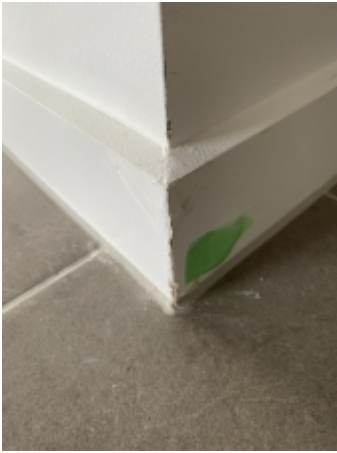
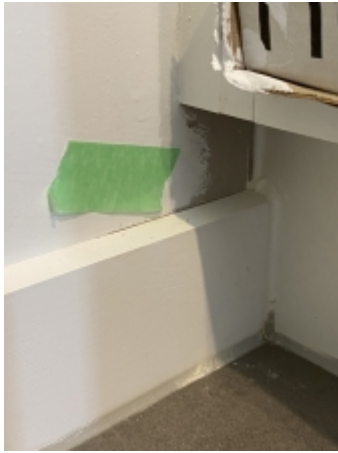
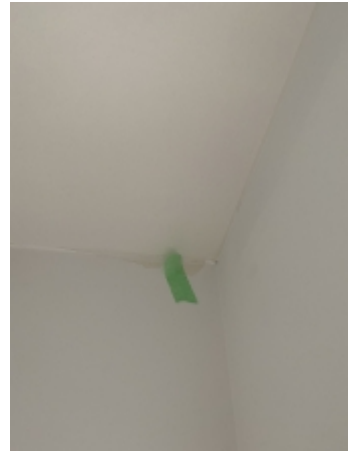
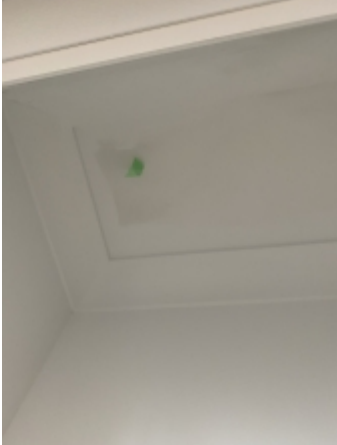
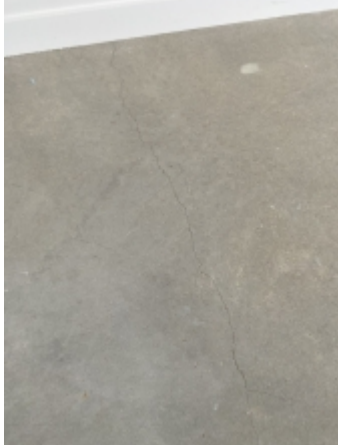
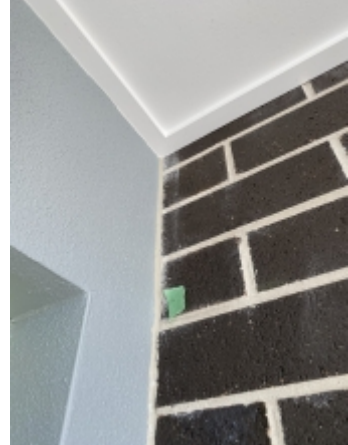
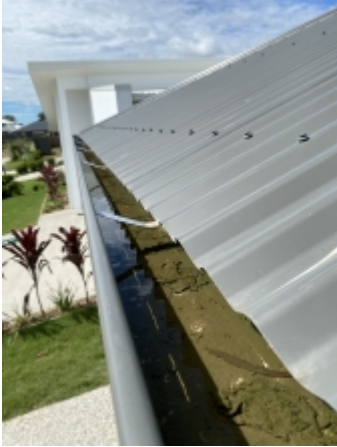
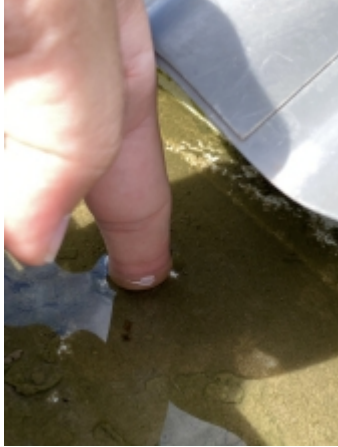
Additional comments	<p>Handover Inspection Defect Lists:</p> <ul style="list-style-type: none"> - All paint touch ups and minor plastering defects been marked with the Green Tape throughout property. - Final clean needed to the internal and external surfaces including claddings and glazings. - Improve Paint detail to the front door especially edges, inconsistent. - Missing paint to the hard ware installation. - Course finish and excess paint residues to the wardrobe. - Incomplete patch mark to the the wall of wardrobe, prep and paint. - Inconsistent silicon / paint runs to the door frame junctions in the ensuite bathroom. - Silicone been shrunk back Freon tile junction to the door architraves in the ensuite bathroom. - Seal rear edges of toilet pan to the wall junctions to improve sanitation as per BCA. - Adjustment/ maintenance needed to the vanity cabinet drawer to operate smoothly. - Impact damage / dints/ course brush mark to the wall and skirting junctions in the Hallway entry to study - Paint touch ups to the smoke detector alarm hasn't been done satisfactory, dis colouration visible from NVP to the separate locations. - Signs of over spray, paint blanketing/ paint runs to the few door/ window reveals and architraves, prep and re gloss needed. - Inconsistent paint finish to the window in the bathroom. - Nail heads visible till the skirting near main bathroom entry, prep and paint. - Shower screen was leaking at the time of inspection, installer / caulker to rectify. - Impact damage to the skirting mitre junctions. - Incomplete paint work to the pantry walls under side of the shelving panels. - Remove protective tapes & excess paint from fridge recess cabinet. - Complete Paint works to the laundry cupboard/ storage. - Gutters retaining water, consistent with debris presence or insufficient fall, to avoid rust and corrosion in future. - Shrinkage crack to the Garage slab, recommend monitoring at this stage. <p>Defects to be rectified by: Industry Standard is 10 working days Has the property reached 'Practical Completion': YES.</p>

Showing defects throughout the property
