10 Byambee St 10 Byambee St, Kenmore QLD 4069, Australia

## Pre-Purchase Standard Property & Timber Pest Report

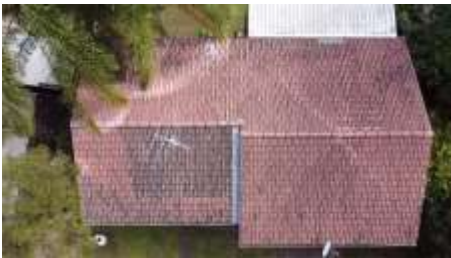
Showing samples of Obstructions

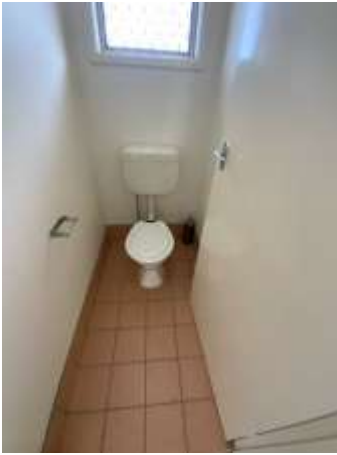
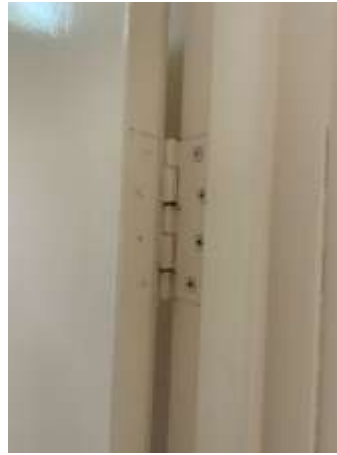
Showing toilet without lift-off hinges

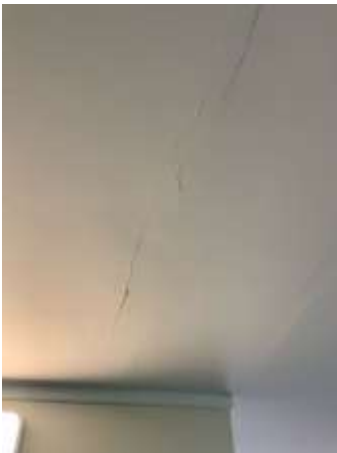
Sagging and Creasing visible on ceiling plasterboards, Recommend repair by engaging a licensed Plasterer.

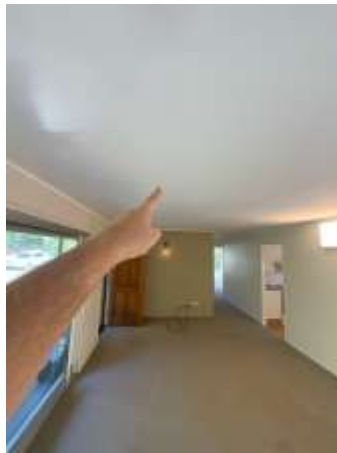
Sagging and Creasing visible on ceiling plasterboards, Recommend repair by engaging a licensed Plasterer.

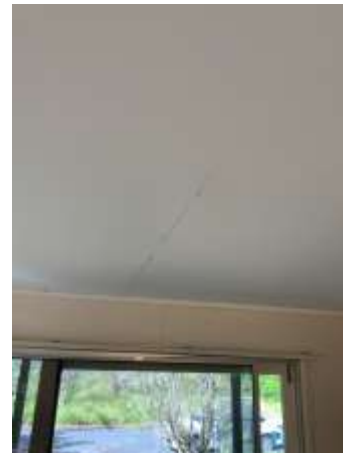
Sagging and Creasing visible on ceiling plasterboards, Recommend repair by engaging a licensed Plasterer.

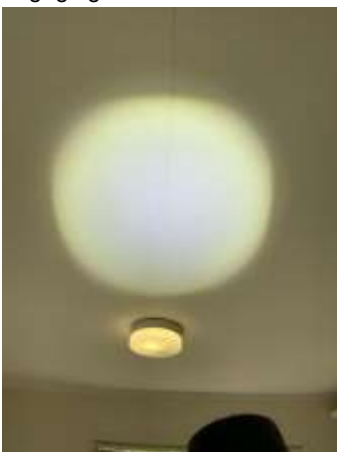
Sagging and Creasing visible on ceiling plasterboards, Recommend repair by engaging a licensed Plasterer.

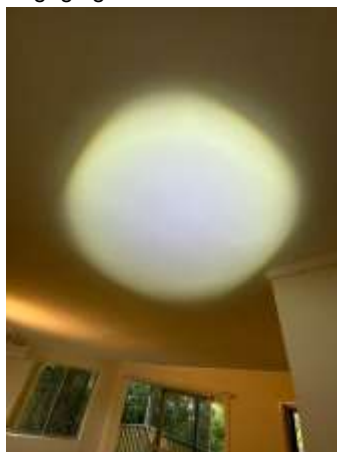
Sagging and Creasing visible on ceiling plasterboards, Recommend repair by engaging a licensed Plasterer.

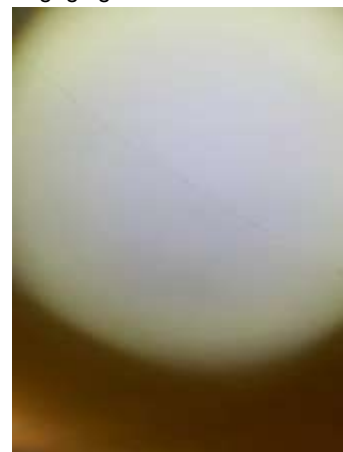
Sagging and Creasing visible on ceiling plasterboards, Recommend repair by engaging a licensed Plasterer.

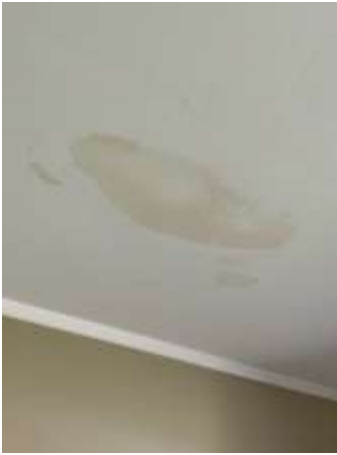
Moisture/mould staining to ceiling, recommend engaging a Roofer to fix the upper roof to reduce the risk of water leaks from roof coverings, penetration & flashings

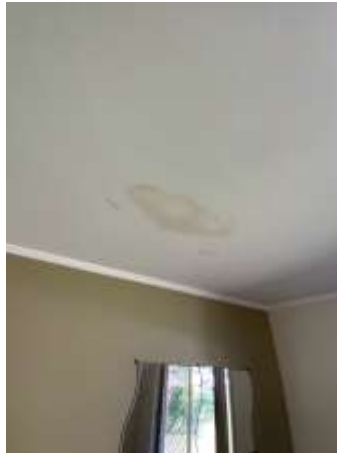
Moisture/mould staining to ceiling, recommend engaging a Roofer to fix the upper roof to reduce the risk of water leaks from roof coverings, penetration & flashings

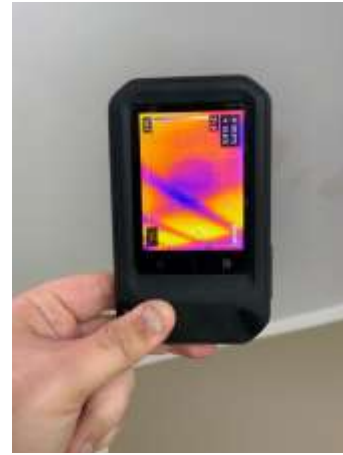
Moisture/mould staining to ceiling, recommend engaging a Roofer to fix the upper roof to reduce the risk of water leaks from roof coverings, penetration & flashings

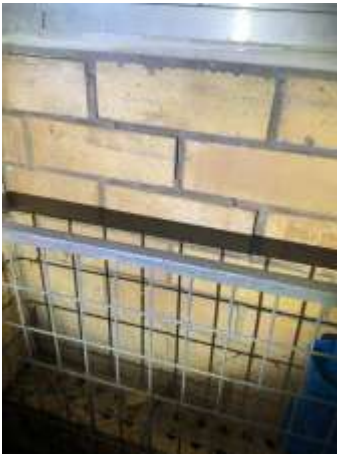
Diagonal crack patterns around openings, Due to the extent, pattern & width of cracks, highly advise to consult with a Licensed Structural Engineer.

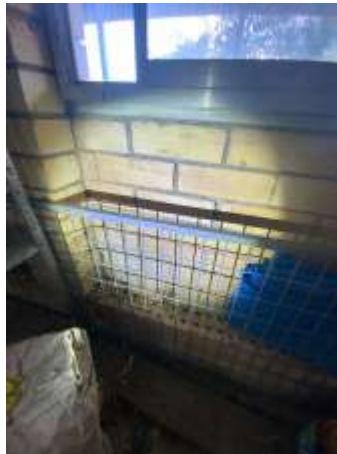
Diagonal crack patterns around openings, Due to the extent, pattern & width of cracks, highly advise to consult with a Licensed Structural Engineer.

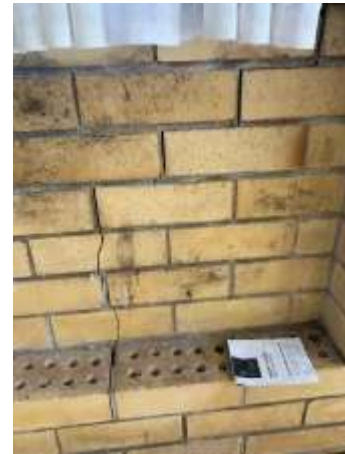
Diagonal crack patterns around openings, Due to the extent, pattern & width of cracks, highly advise to consult with a Licensed Structural Engineer.

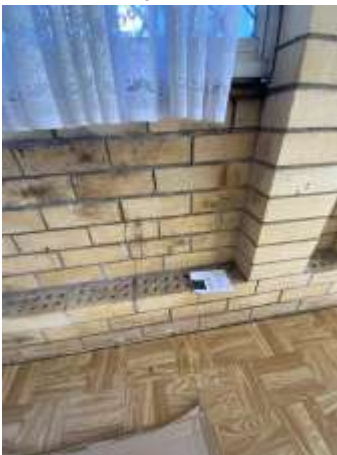
Diagonal crack patterns around openings, Due to the extent, pattern & width of cracks, highly advise to consult with a Licensed Structural Engineer.

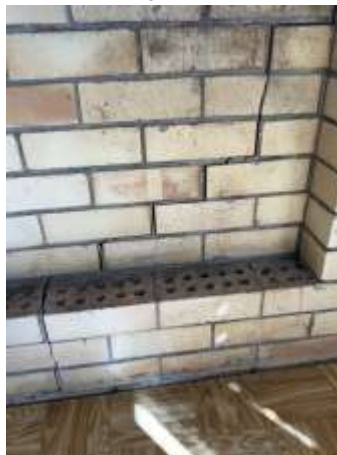
Diagonal crack patterns around openings, Due to the extent, pattern & width of cracks, highly advise to consult with a Licensed Structural Engineer.

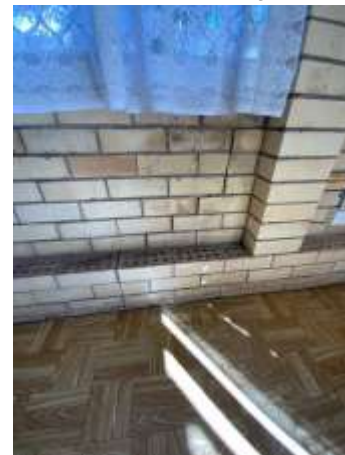
Diagonal crack patterns around openings, Due to the extent, pattern & width of cracks, highly advise to consult with a Licensed Structural Engineer.

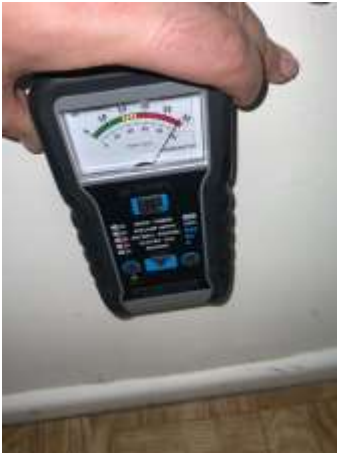
High moisture reading to walls adjacent to the Bathroom / Shower recess-Recommend engaging a Builder for further invasive investigation to ascertain cause and to determine if there is any concealed damage to the timber framing., Downstairs Bathroom

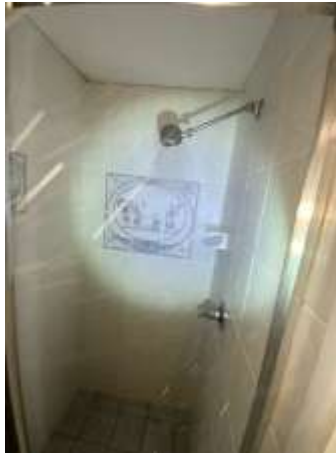
High moisture reading to walls adjacent to the Bathroom / Shower recess-Recommend engaging a Builder for further invasive investigation to ascertain cause and to determine if there is any concealed damage to the timber framing., Downstairs Bathroom

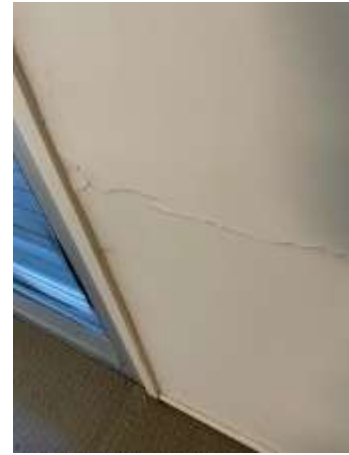
Common crack to parts of Internal walls (Fluctuations in temperature and humidity levels can cause framing members and drywall to expand and contract, resulting in cracking). Repair by engaging a licensed Plasterer / Painter.

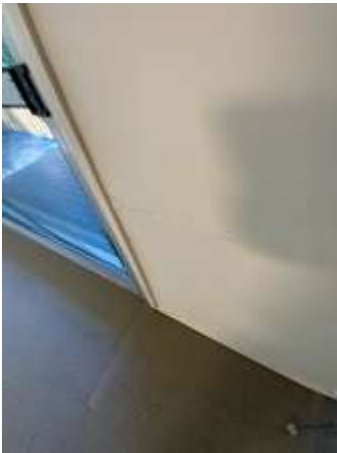
Common crack to parts of Internal walls (Fluctuations in temperature and humidity levels can cause framing members and drywall to expand and contract, resulting in cracking). Repair by engaging a licensed Plasterer / Painter.

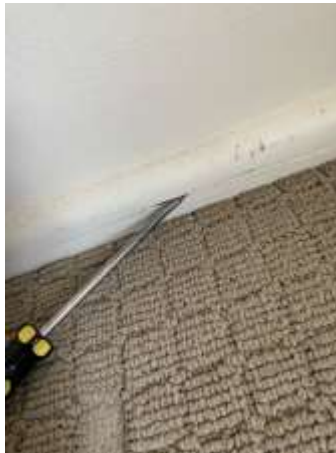
Termite damage noted to the Wall Skirting in Bedroom 2, Highly recommend engage a Builder for further investigation to determine the extent of damage and repair proposals.

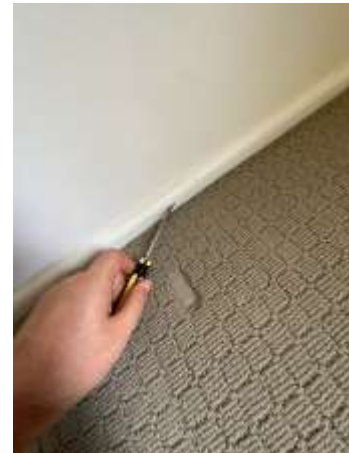
Termite damage noted to the Wall Skirting in Bedroom 2, Highly recommend engage a Builder for further investigation to determine the extent of damage and repair proposals.

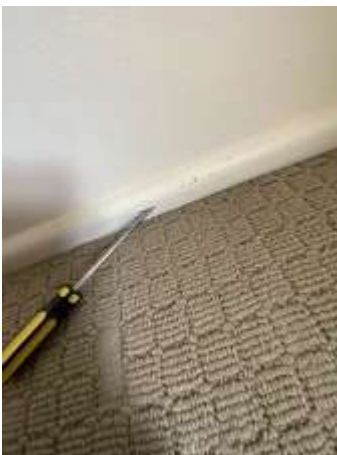
Termite damage noted to the Wall Skirting in Bedroom 2, Highly recommend engage a Builder for further investigation to determine the extent of damage and repair proposals.

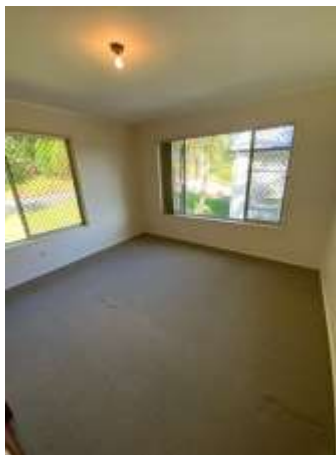
Termite damage noted to the Wall Skirting in Bedroom 2, Highly recommend engage a Builder for further investigation to determine the extent of damage and repair proposals.

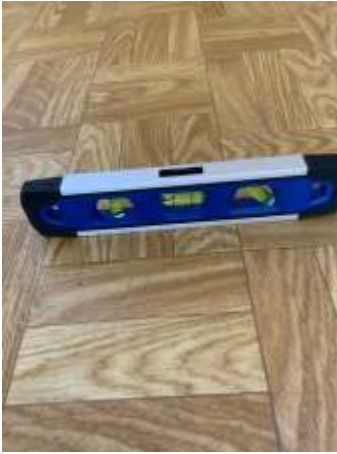
Undulating/uneven floors - recommend engaging a Builder to assess appropriate method of rectification to prevent further deterioration.

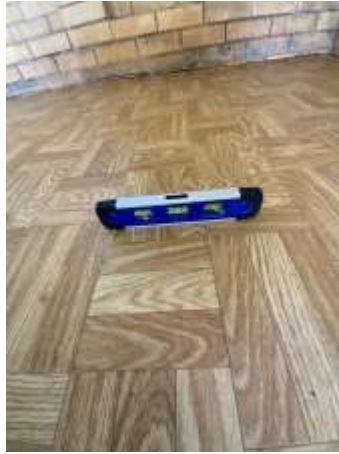
Undulating/uneven floors - recommend engaging a Builder to assess appropriate method of rectification to prevent further deterioration.

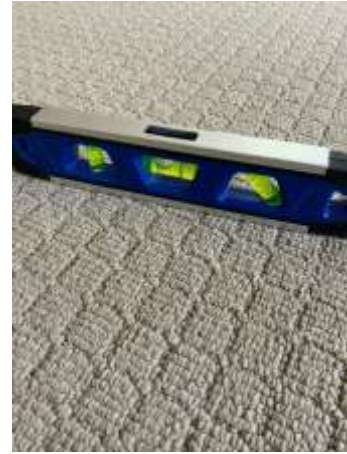
Undulating/uneven floors - recommend engaging a Builder to assess appropriate method of rectification to prevent further deterioration.

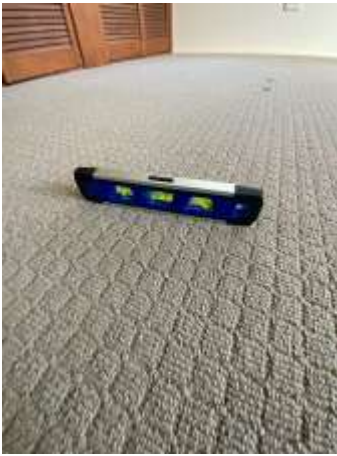
Undulating/uneven floors - recommend engaging a Builder to assess appropriate method of rectification to prevent further deterioration.

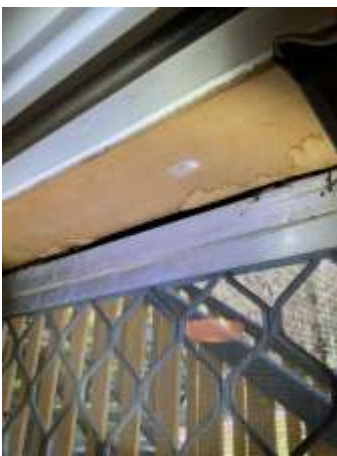
Water damage noted to window reveal, recommend proper sealing around window and replacing affected Timbers.

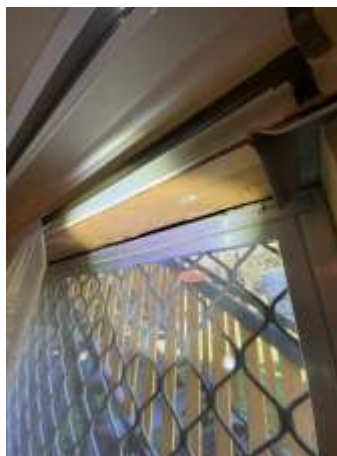
Water damage noted to window reveal, recommend proper sealing around window and replacing affected Timbers.

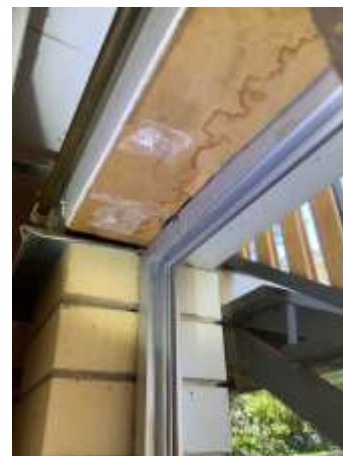
Water damage noted to window reveal, recommend proper sealing around window and replacing affected Timbers.

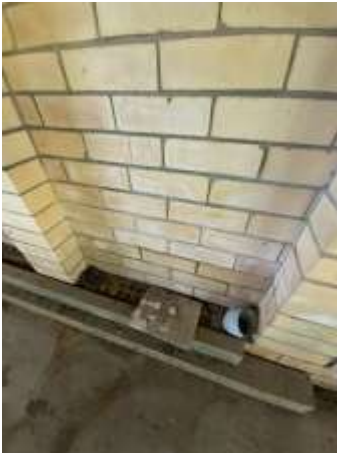
Signs of rising damp to the Brick walls to the Garage, recommend improving the surface drainage behind the wall.

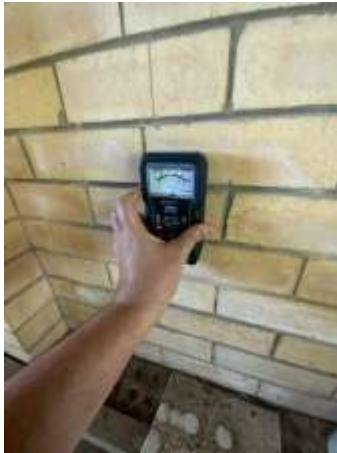
Signs of rising damp to the Brick walls to the Garage, recommend improving the surface drainage behind the wall.

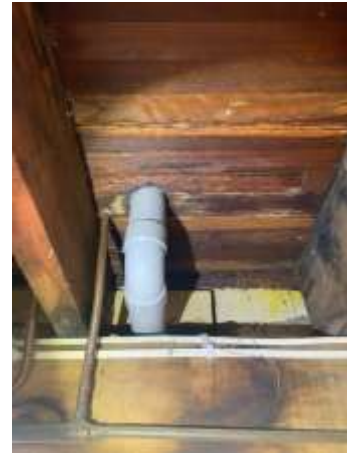
Signs of water damage to Timber flooring, especially around pipe penetration. Engage a Builder for further assessment and repair proposals.

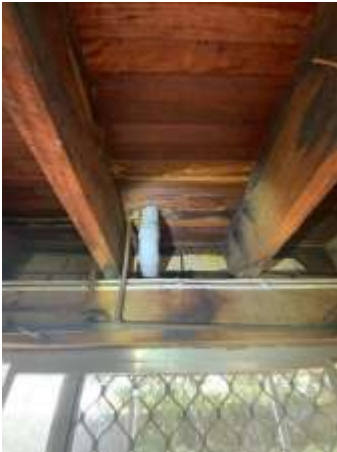
Signs of water damage to Timber flooring, especially around pipe penetration. Engage a Builder for further assessment and repair proposals.

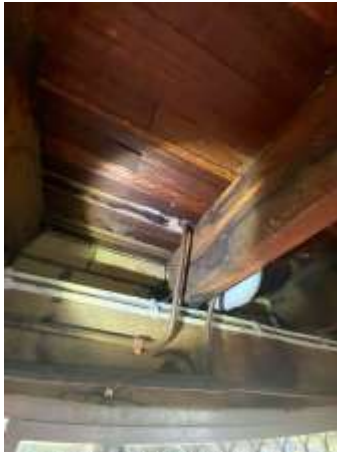
Signs of water damage to Timber flooring, especially around pipe penetration. Engage a Builder for further assessment and repair proposals.

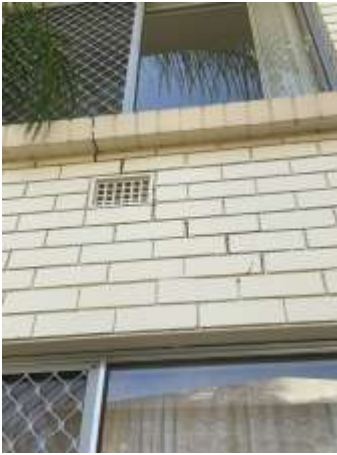
Movement cracking with Diagonal, Vertical, Horizontal pattern noted on the external wall, specifically around openings. A Structural Engineer should be consulted for further evaluation and advice prior to your purchase of the property.

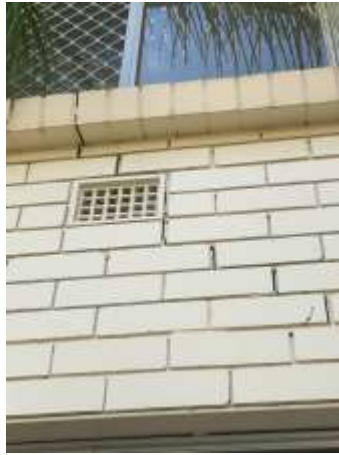
Movement cracking with Diagonal, Vertical, Horizontal pattern noted on the external wall, specifically around openings. A Structural Engineer should be consulted for further evaluation and advice prior to your purchase of the property.

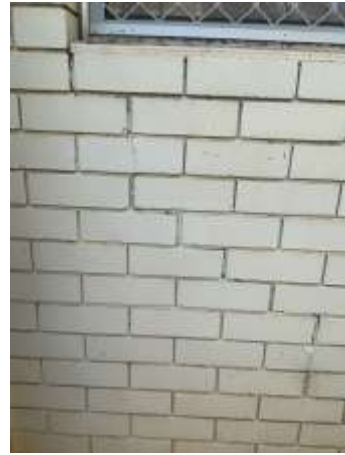
Movement cracking with Diagonal, Vertical, Horizontal pattern noted on the external wall, specifically around openings. A Structural Engineer should be consulted for further evaluation and advice prior to your purchase of the property.

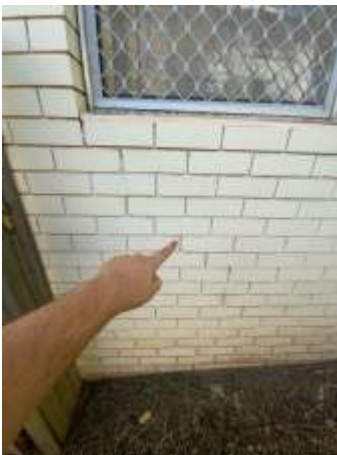
Movement cracking with Diagonal, Vertical, Horizontal pattern noted on the external wall, specifically around openings. A Structural Engineer should be consulted for further evaluation and advice prior to your purchase of the property.

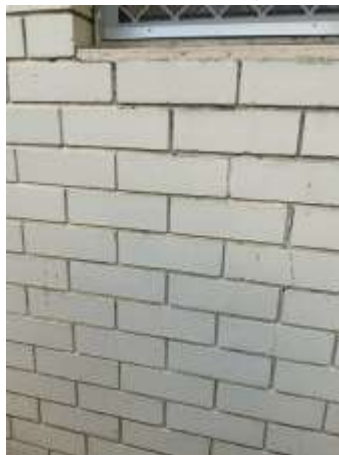
Movement cracking with Diagonal, Vertical, Horizontal pattern noted on the external wall, specifically around openings. A Structural Engineer should be consulted for further evaluation and advice prior to your purchase of the property.

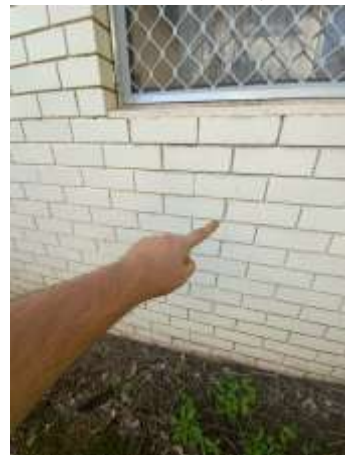
Movement cracking with Diagonal, Vertical, Horizontal pattern noted on the external wall, specifically around openings. A Structural Engineer should be consulted for further evaluation and advice prior to your purchase of the property.

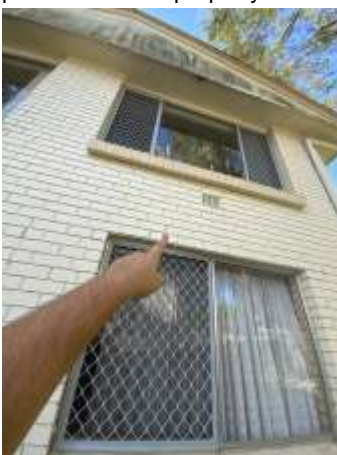
Movement cracking with Diagonal, Vertical, Horizontal pattern noted on the external wall, specifically around openings. A Structural Engineer should be consulted for further evaluation and advice prior to your purchase of the property.

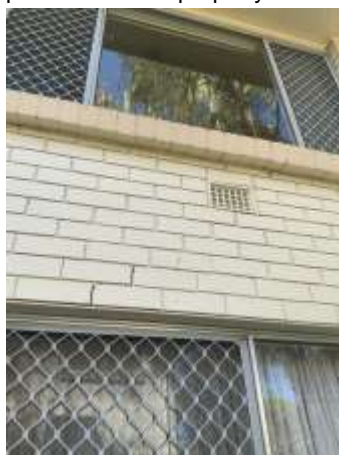
Movement cracking with Diagonal, Vertical, Horizontal pattern noted on the external wall, specifically around openings. A Structural Engineer should be consulted for further evaluation and advice prior to your purchase of the property.

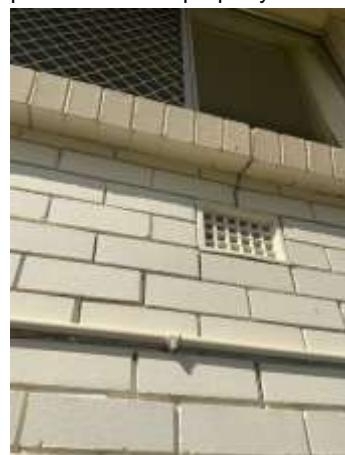
Movement cracking with Diagonal, Vertical, Horizontal pattern noted on the external wall, specifically around openings. A Structural Engineer should be consulted for further evaluation and advice prior to your purchase of the property.

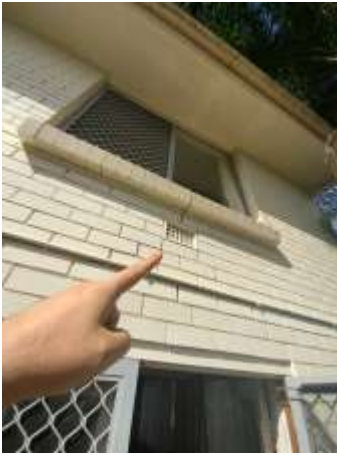
Movement cracking with Diagonal, Vertical, Horizontal pattern noted on the external wall, specifically around openings. A Structural Engineer should be consulted for further evaluation and advice prior to your purchase of the property.

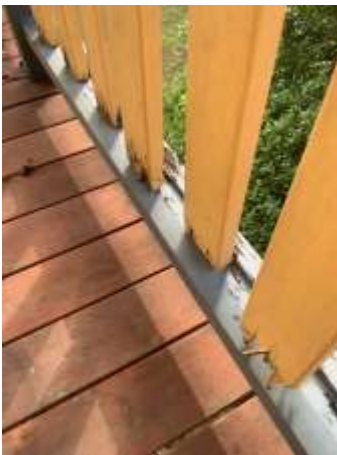
Ageing and weathering to the Timber decking including handrails/balustrades and floorboards, recommend repair/replacing damaged Timbers ASAP.

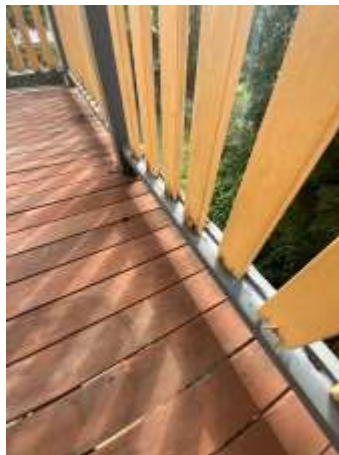
Ageing and weathering to the Timber decking including handrails/balustrades and floorboards, recommend repair/replacing damaged Timbers ASAP.

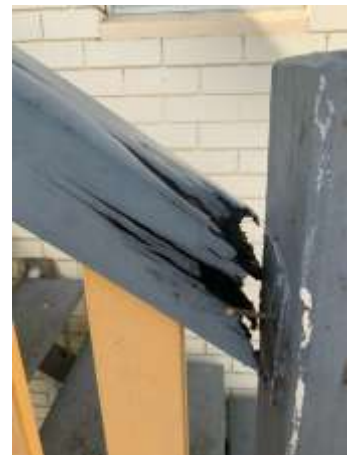
Ageing and weathering to the Timber decking including handrails/balustrades and floorboards, recommend repair/replacing damaged Timbers ASAP.

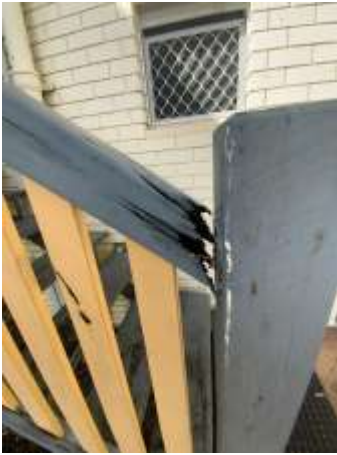
Ageing and weathering to the Timber decking including handrails/balustrades and floorboards, recommend repair/replacing damaged Timbers ASAP.

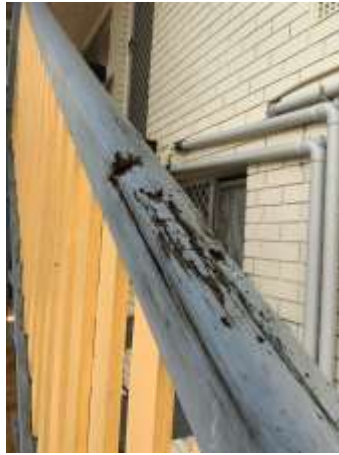
Ageing and weathering to the Timber decking including handrails/balustrades and floorboards, recommend repair/replacing damaged Timbers ASAP.

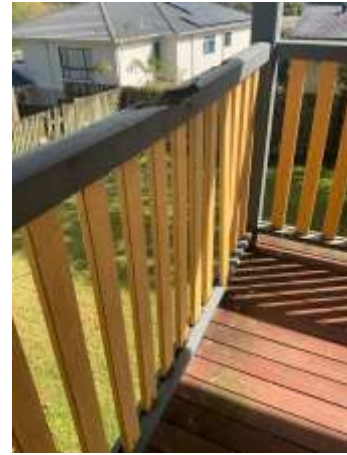
Ageing and weathering to the Timber decking including handrails/balustrades and floorboards, recommend repair/replacing damaged Timbers ASAP.

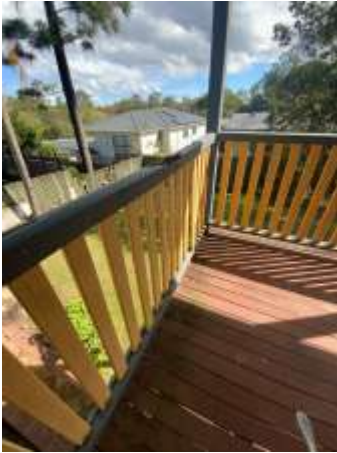
Ageing and weathering to the Timber decking including handrails/balustrades and floorboards, recommend repair/replacing damaged Timbers ASAP.

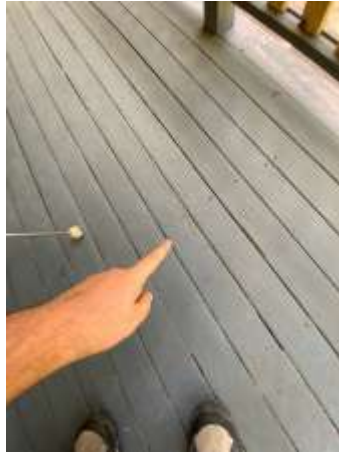
Ageing and weathering to the Timber decking including handrails/balustrades and floorboards, recommend repair/replacing damaged Timbers ASAP.

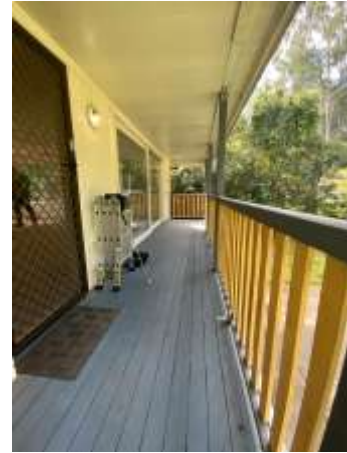
Ageing and weathering to the Timber decking including handrails/balustrades and floorboards, recommend repair/replacing damaged Timbers ASAP.

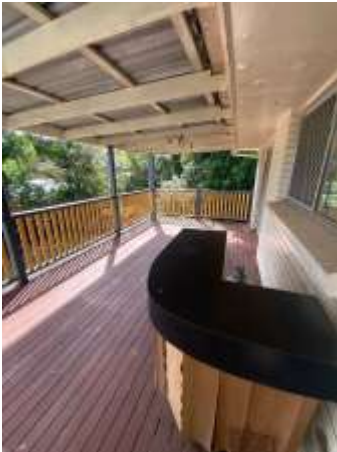
Ageing and weathering to the Timber decking including handrails/balustrades and floorboards, recommend repair/replacing damaged Timbers ASAP.

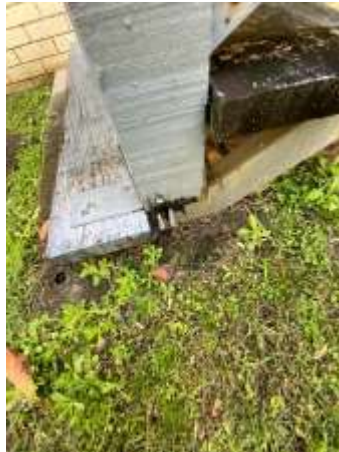
Ageing and weathering to the Timber decking including handrails/balustrades and floorboards, recommend repair/replacing damaged Timbers ASAP.

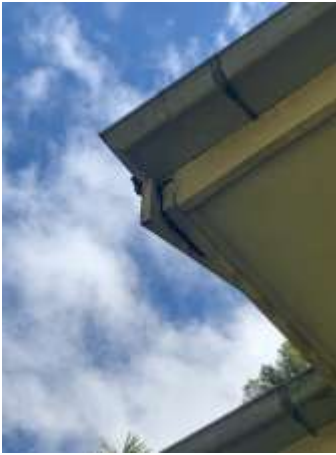
Aged, weathered and deteriorated fascia/ridge - needs repair/replacing.

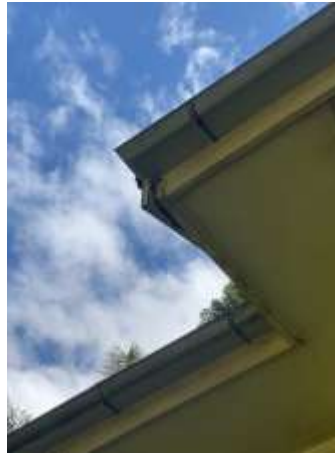
Aged, weathered and deteriorated fascia/ridge - needs repair/replacing.

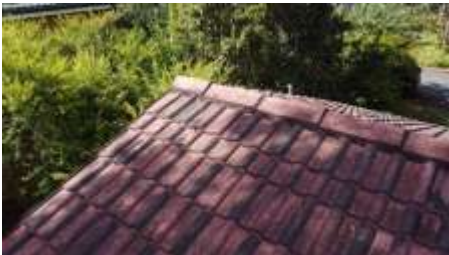
Few chipped and dislocated tiles noted to roof exterior coverings, recommend engage a roofer to rectify.

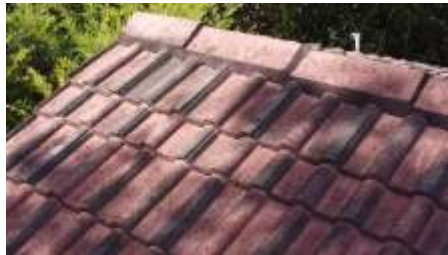
Few chipped and dislocated tiles noted to roof exterior coverings, recommend engage a roofer to rectify.

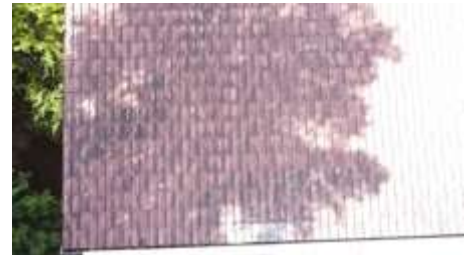
Few chipped and dislocated tiles noted to roof exterior coverings, recommend engage a roofer to rectify.

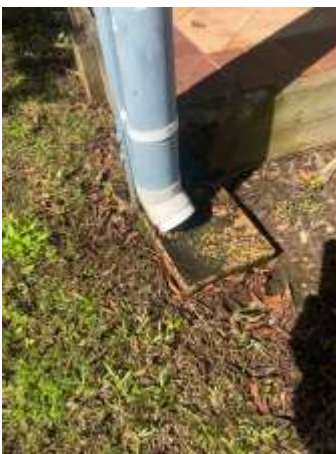
Few Downpipes damaged/cracked/dismounted or not properly connected to stormwater system- Recommend engaging a Plumber to repair & avoid the risk of foundation movement & other moisture related issues.

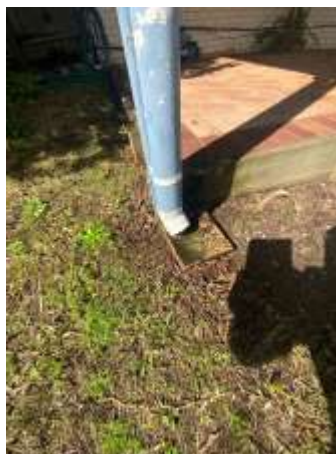
Few Downpipes damaged/cracked/dismounted or not properly connected to stormwater system- Recommend engaging a Plumber to repair & avoid the risk of foundation movement & other moisture related issues.

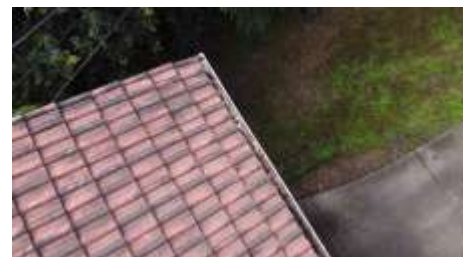
Gutters in several areas been blocked by debris, twigs and leaves. Needs cleaning to avoid ongoing leak issue and minimise risk of overflowing into Eave space and deterioration.

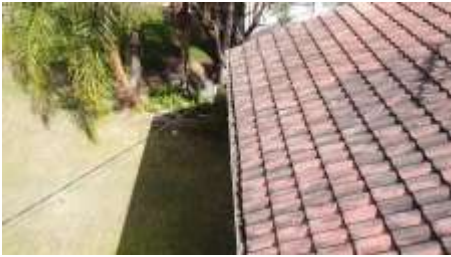
Gutters in several areas been blocked by debris, twigs and leaves. Needs cleaning to avoid ongoing leak issue and minimise risk of overflowing into Eave space and deterioration.

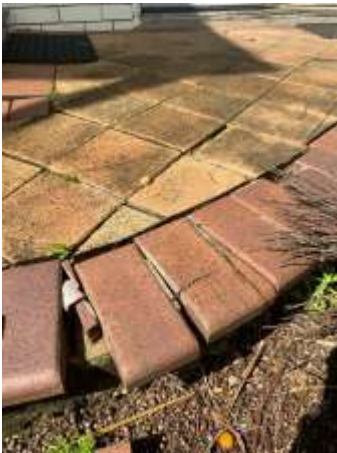
Showing undulations to the brick pavement on separate elevations, risk of water ponding and foundation movement.

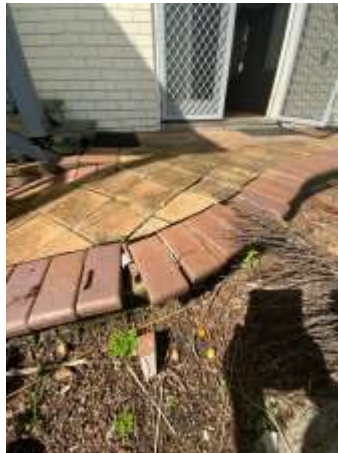
Showing undulations to the brick pavement on separate elevations, risk of water ponding and foundation movement.

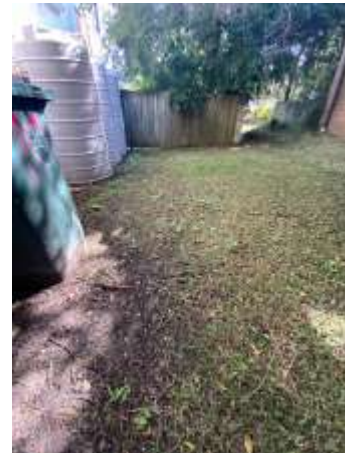
Poor surface drainage -needs improvement to reduce the risk of footing movement and other moisture related issues by properly diverting rain run offs away from building into collection point ( catch basin)

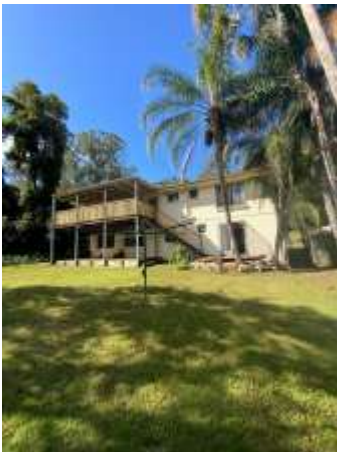
Poor surface drainage -needs improvement to reduce the risk of footing movement and other moisture related issues by properly diverting rain run offs away from building into collection point ( catch basin)

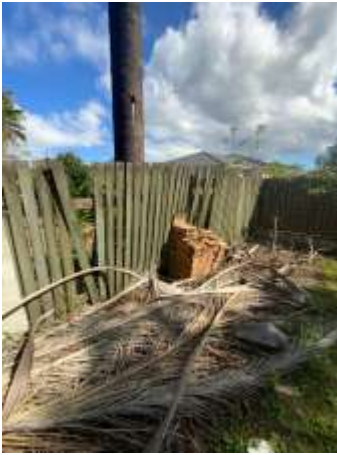
Leaning fences to parts - recommend engaging a Builder or Fencer to rectify to prevent further deterioration.

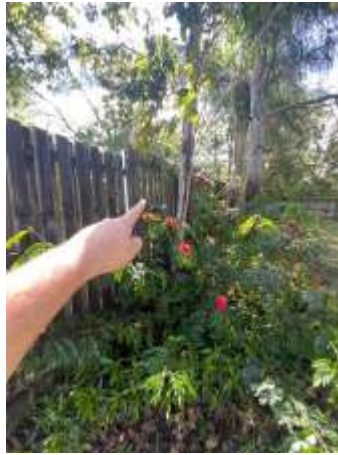
Leaning fences to parts - recommend engaging a Builder or Fencer to rectify to prevent further deterioration.

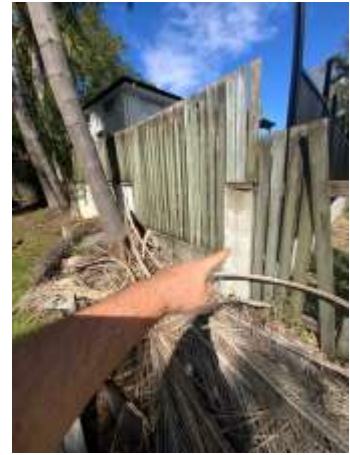
Concrete block boundary walls leaning to parts, recommend engage a Builder to rectify.

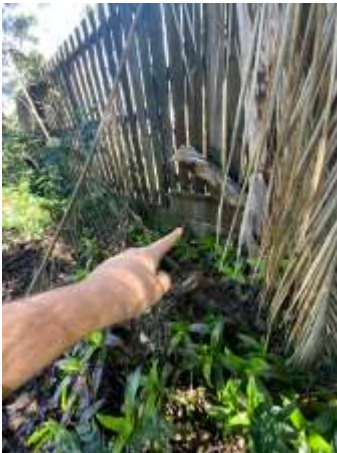
Concrete block boundary walls leaning to parts, recommend engage a Builder to rectify.

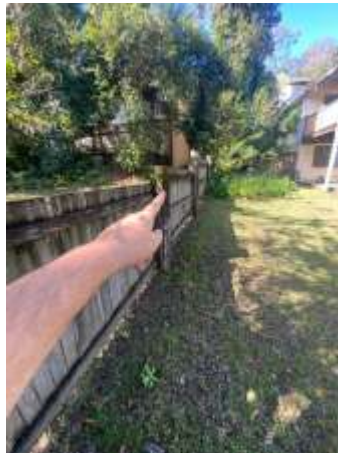
Concrete block boundary walls leaning to parts, recommend engage a Builder to rectify.

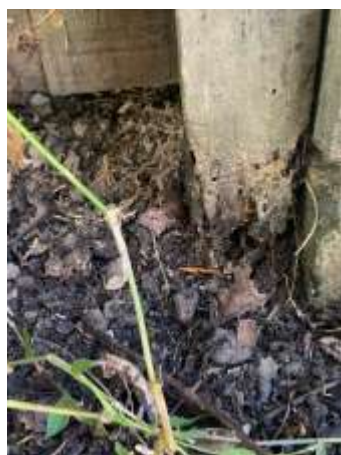
Showing evidence of Termite Workings

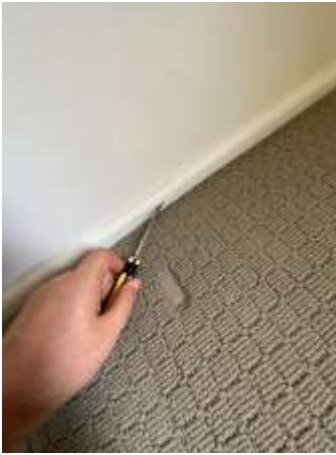
Showing evidence of Termite Workings

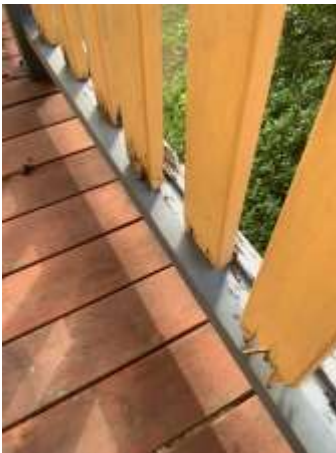
Showing evidence of Fungal Decay

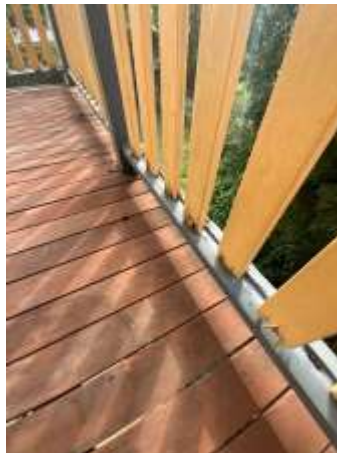
Showing evidence of Fungal Decay

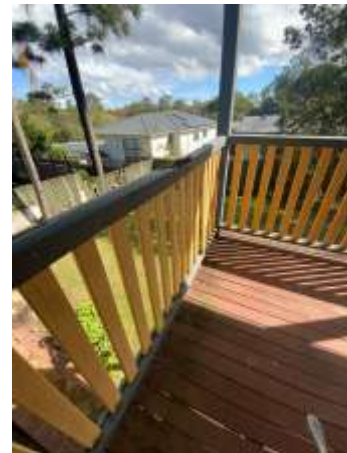
Showing evidence of Fungal Decay

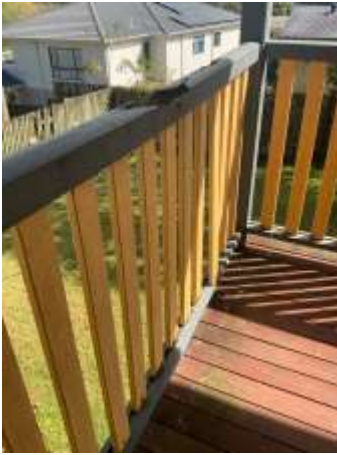
Showing evidence of Fungal Decay

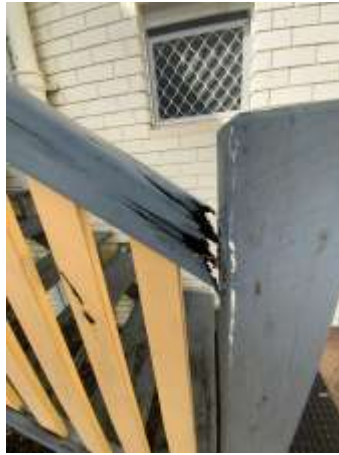
Showing evidence of Fungal Decay

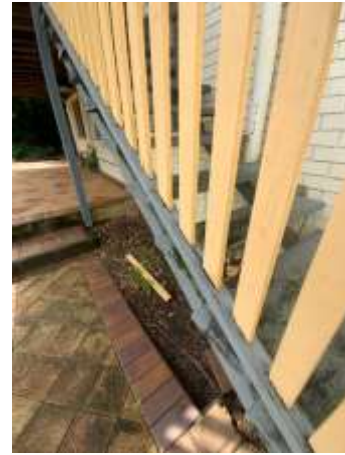
Showing evidence of Fungal Decay

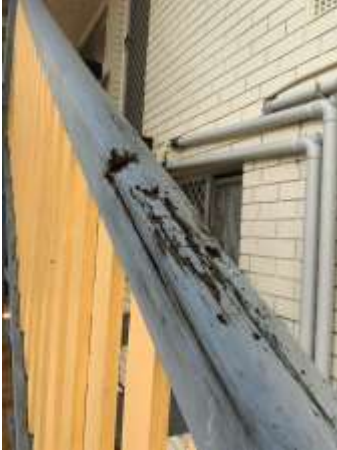
Showing evidence of Fungal Decay

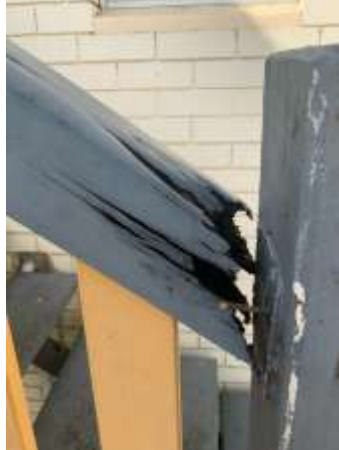
Showing evidence of Fungal Decay

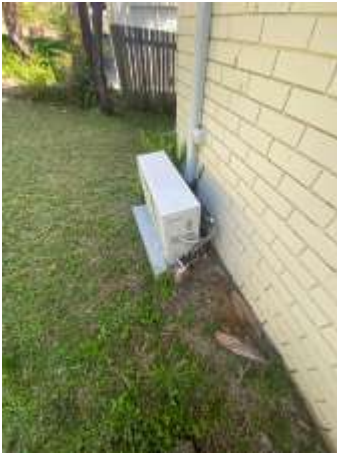
Showing samples of Excessive Moisture

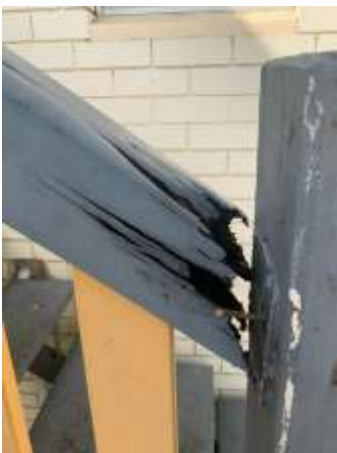
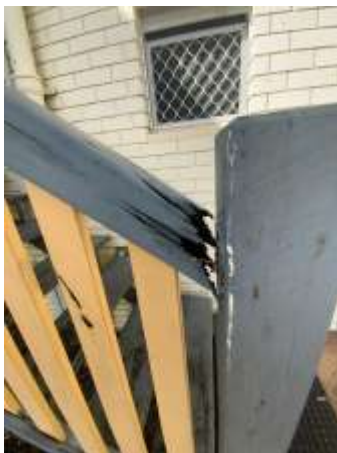
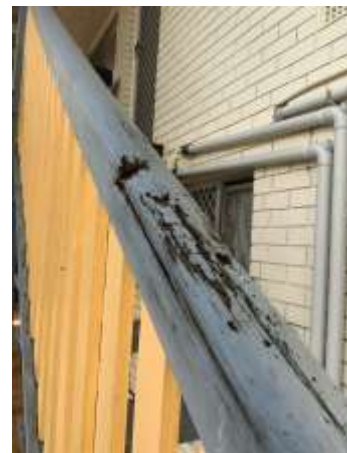
Showing evidence of Timber Safety Hazard Showing evidence of Timber Safety Hazard Showing evidence of Timber Safety Hazard

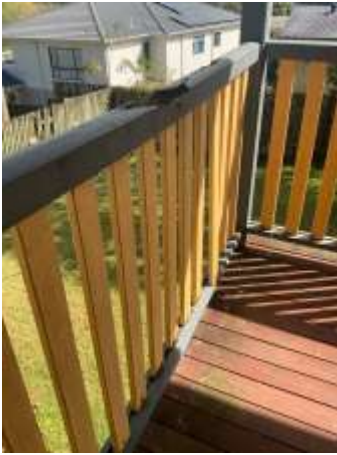
Showing evidence of Timber Safety Hazard

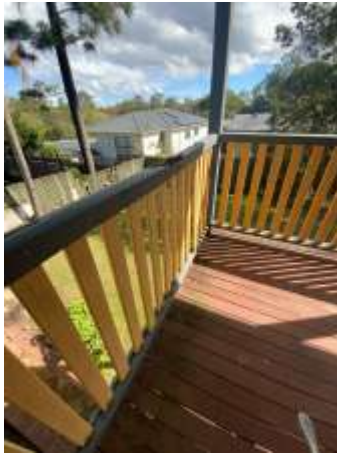
Showing evidence of Timber Safety Hazard

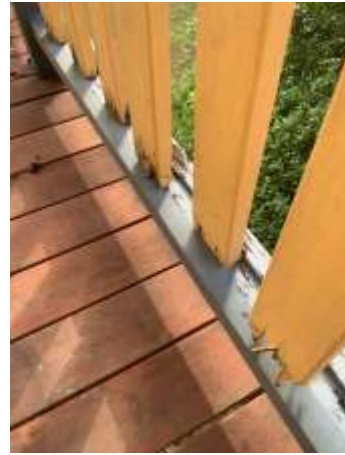
Showing evidence of Timber Safety Hazard

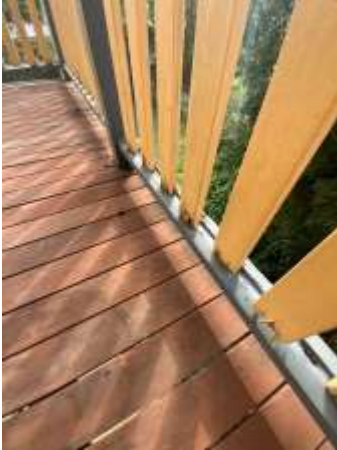
Showing evidence of Timber Safety Hazard

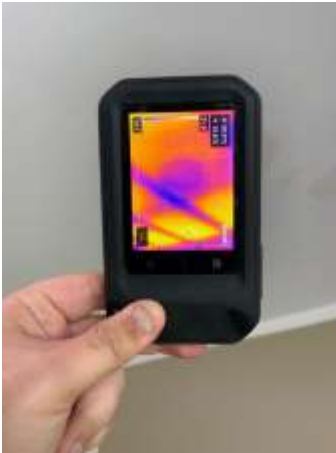
Thermal Imaging Camera and Moisture Detector photos

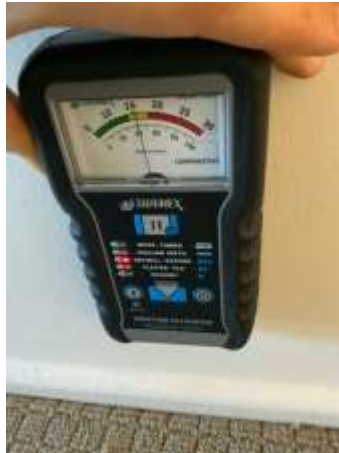
Thermal Imaging Camera and Moisture Detector photos

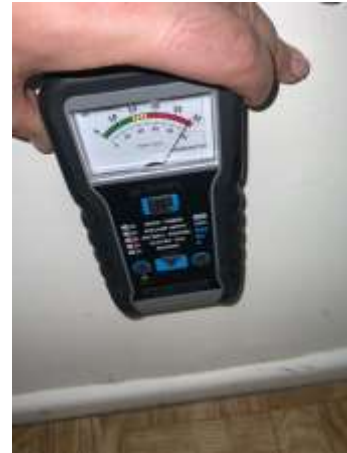
Thermal Imaging Camera and Moisture Detector photos

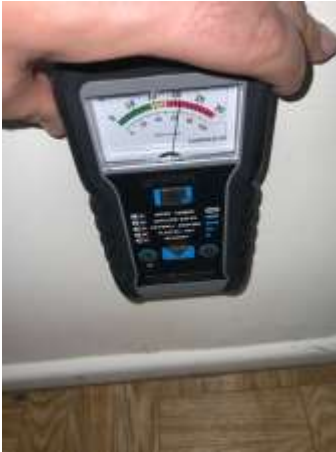
Thermal Imaging Camera and Moisture Detector photos

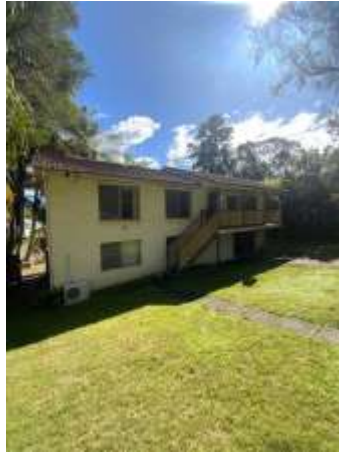
Showing General photos
